## GEOLOGICAL CONDITIONS UNDER THE AKASHI STRAITS

## SUBSTRUCTURES OF THE AKASHI KAIKYO BRIDGE

### CHANGES FOLLOWING THE EARTHQUAKE

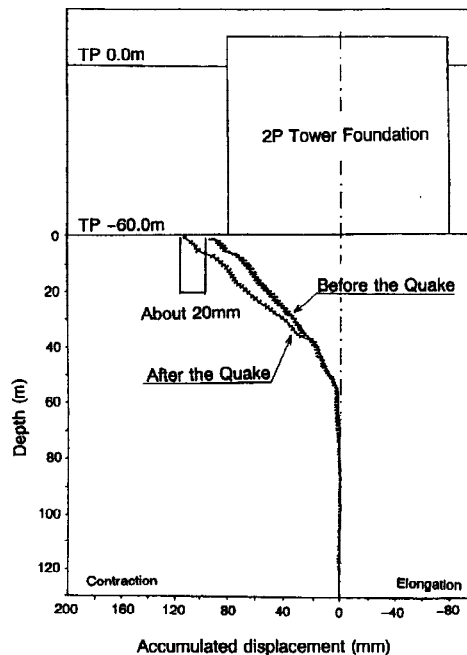
Fig. 8. Results of measurements on 2P with a sliding micrometer before and after the earthquake

[4] Regarding the tower foundations (2P and 3P), displacement of the bearing ground due to subsidence was measured with a sliding micrometer. The results are shown in Fig. 8. The 2P tower foundation subsided by about 20 mm (strain:  $4 \times 10^{-4}$ ) as a result of the earthquake, probably because the bearing Akashi strata was compacted.
