## GEOLOGICAL CONDITIONS UNDER THE AKASHI STRAITS

## SUBSTRUCTURES OF THE AKASHI KAIKYO BRIDGE

### CHANGES FOLLOWING THE EARTHQUAKE

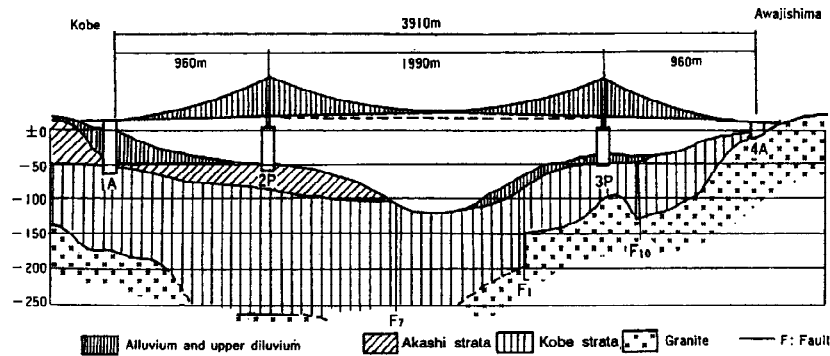
Fig. 1. Geological profile near the Akashi Kaikyo Bridge

Fig. 1 summarizes the results of these surveys. The strata comprises granite dating back to the end of the Mesozoic era, which is covered, in unconformity, by Kobe strata belonging to the Miocene epoch of the Neogene period, and then by the Akashi layer, upper diluvium, and alluvium belonging to the Diluvium epoch of the Quaternary period.

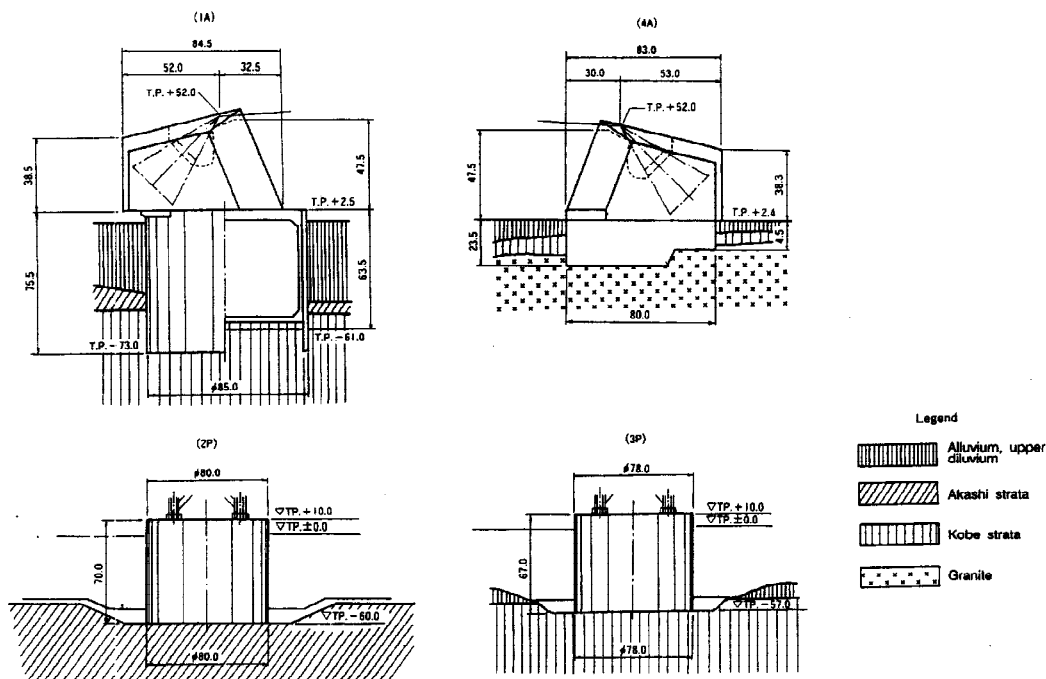
Fig. 4. Overall structure of the foundations (unit: m)

The 1A and 4A foundations are of the gravity anchorage type. Anchorage 1A consists of a caisson foundation 85 m in diameter and 63.5 m in depth laid on the Kobe strata plus a main body which is 84.5 m in length and 63 m in width. Anchorage 4A is a spread foundation, 80 m in length, 63 m in width, and 23.5 m in depth (at the deepest point) laid on the granite bedrock. Fig. 4 shows the overall structure of these foundations.

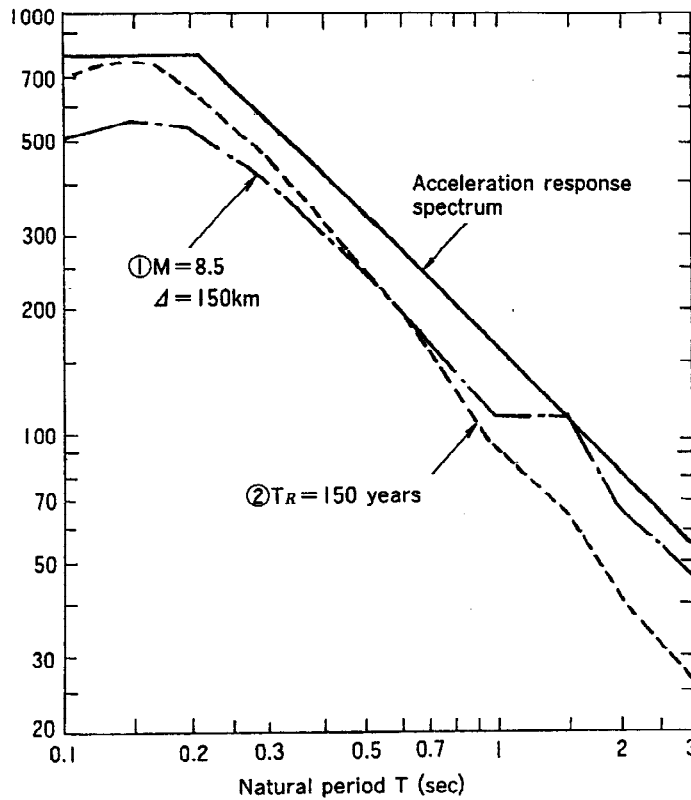
Fig. 5. Design acceleration response of the Akashi Kaikyo Bridge

The input acceleration resulting from the design earthquake — which is common to all the bridge foundations — is defined as the envelope mapped by the following two acceleration response spectra (see Fig. 5):

- [1] Acceleration response spectrum at the bridge site resulting from an earthquake of M8.5 off the Kii Peninsula (distance from epicenter: 150 km); and
- [2] Acceleration response spectrum corresponding to earthquakes with a recurrence interval of 150 years based on a stochastic assessment of past earthquakes (within a radius of 300 km and of magnitude greater than M6), so as to take into account the possibility of earthquake forces stronger than [1] above.
